# OMEGA: A NEW COLD X-RAY SIMULATION FACILITY FOR THE EVALUATION OF OPTICAL COATINGS

J. H. Fisher, C. D. Newlander, K. B. Fournier, D. E. Beutler, C. A. Coverdale, M. J. May, M. Tobin, J. F. Davis, D. Shiekh

May 1, 2007

Journal of Radiation Effects, Research and Engineering

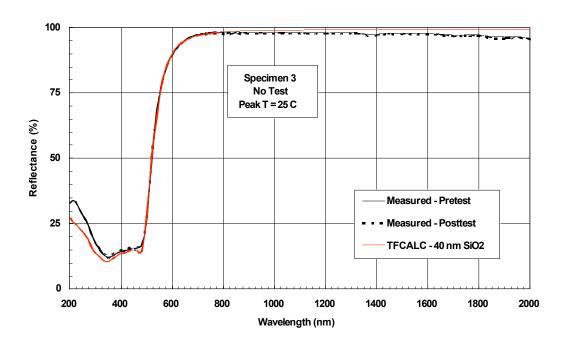
Figure 8. Pre- and Posttest Reflectance for Specimen 3 (untested)

Posttest reflectance measurements on the tested and spare (untested) specimens were performed by Surface Optics Corporation. In addition, GH Systems performed TFCALC calculations to compare with the measured data. Figure 8 presents the pre- and posttest reflectance measurements on Specimen 3 which was untested and therefore should show no X-ray exposure effects, but should show any degradation due to handling or storage. Note that the posttest measurements were performed from 300 to 3000 nm rather than down to 200 nm as for the pretest measurements. There is essentially no difference between the pre- and posttest measurements and the TFTCALC calculations show good correlation with the data above 300 nm.

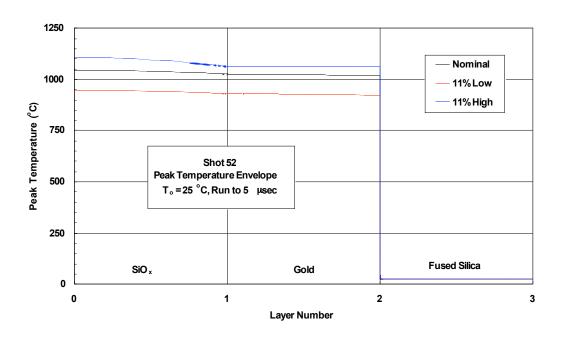
Figure 11. Calculated Peak Temperature Envelope for Specimen 1 (Shot 52)

The models used were developed by Newlander and Childs $^6$ . The SiO $_x$  coating model used was that developed for fused silica (Corning 7940) and may contain significant uncertainties. Few thermophysical properties are available for thin film coating materials. The calculations used the spectra provided by LLNL and piece-wise linear fits to the SNL-provided flux-time profiles. The fluences used were the nominal based upon the yield determined by the integration of the LLNL spectra and  $\pm 11\%$  uncertainties to represent the extremes based on the data reduction techniques. All of the calculations showed that the nominal fluence gave peak temperatures in the gold layer very near or exceeding the gold melt temperature. These temperatures are reduced when the lower limit (-11%) of the fluence is used. Since no gold melt was observed, it is suspected that the nominal fluences may be somewhat too high. Figure 11 shows the calculated peak temperature envelope for Specimen 1 (Shot 52) which was fielded unfiltered. Here the peak temperature in the gold is  $1026^{\circ}$ C, which is very near the gold melt of  $1064^{\circ}$ C. Decreasing the fluence by 11% generates a lower peak temperature of  $931^{\circ}$ C.

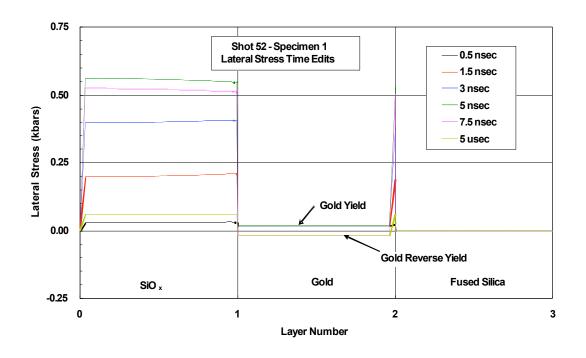
Figure 12. Calculated Lateral Stress Profiles for Specimen 1 (Shot 52)

The lateral stresses are those stresses induced by expansion of the heated layers in the lateral direction (i.e. along the face of the mirror). The differential expansion of the layers will generate shear stresses along the interface as well as compressive or tensile stresses within the layer which may lead to damage or fracture within the material layer. PUFFTFT can be used to estimate these lateral stresses. Figure 12 shows the calculated lateral stress response in the layers for Specimen 1 at various times. The gold layer yields and goes into reverse yield during later times as the layer cools. The stress difference between the  $SiO_x$  and gold, and the gold and fused silica substrate are large (>0.5 kbars). However, calculations for Specimen 6 (Shot 53) showed stress differentials exceeding 0.75 kbars. There was no damage observed for that specimen. The lateral stress analyses suggest that the removal of the silica protective layer was not the result of excessive shear stresses unless there is a very large specimen-to-specimen variation. Because all of the specimens were processed and fabricated in the same manner and coated in one batch it is doubtful that these variations occurred.

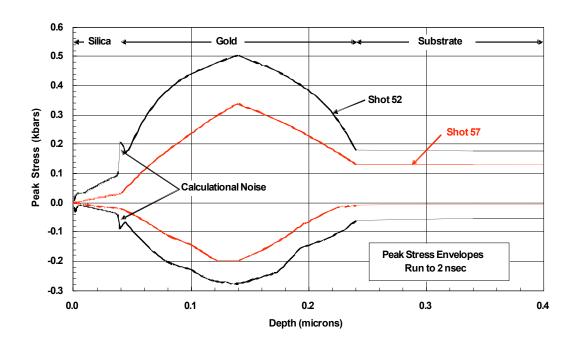
Figure 13. Peak Stress Envelopes Calculated for Shots 52 and 57

Calculations were performed to determine the transverse stress wave response of the specimens. It was felt that the damage seen in the Shot 52, which was unfiltered, might be due to the stress waves generated in the silica coating due to the absorption of the low energy X-rays and UV. The stress wave transit time through the silica is very short (~0.01 nsec), and therefore the calculation was only run to 2 ns which would allow for many stress wave transit times through the silica layer to occur. Figure 13 shows the calculated peak stress envelopes for Shots 52 and 57 run to 2 nsec. The silica coating was completely removed in Shot 52 and intact in Shot 57. There is some very early time noise in Shot 52, but the trend indicates that the generated peak tensile stresses at the silica/gold interface could be nearly a factor of two larger in Shot 52 than in Shot 57. Tensile stress levels of about 0.2 kbars may be sufficient to fail the interface. Spall or delamination of the silica layer is probably the cause of the silica coating layer removal.
